Mt. Carmel Airport Cores Regarding Epoxy Striping

Thomas G. Zehr, P.E., Bituminous Field Engineer and Violet Goodman, Chemist Illinois Department of Transportation Bureau of Materials and Physical Research Springfield, Illinois 62704

AUGUST 2005

CORE AND EPOXY STRIPING ANALYSIS

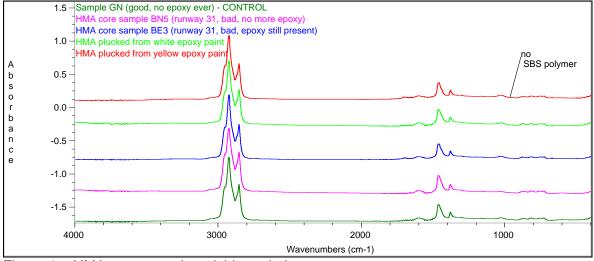
Figure 1 – HMA extracts using trichloroethylene

The spectra of all HMA samples are all identical to the control sample and do not show any unusual peaks. They also did not show any identifying peak for the SBS polymer that is used in polymer modified asphalt cement. This spectrum is typical of PG graded asphalt cement that is dissolved in TCE.

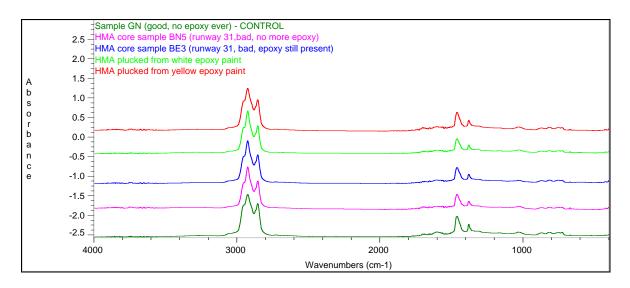
Figure 2 – HMA extracts using methylene chloride

The spectra of all HMA samples are all identical to the control sample and do not show any unusual peaks. This spectrum is typical of asphalt cement that is dissolved in MC.

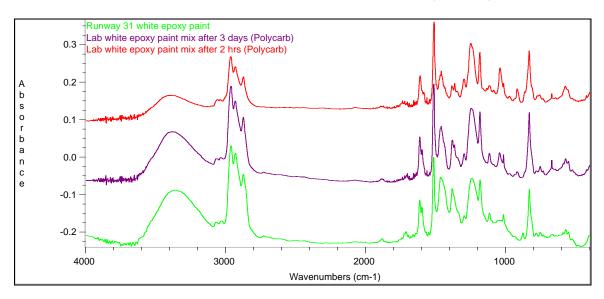
Figure 3 – White epoxy paint extracts using methylene chloride

Both field (runway 31) and laboratory samples of the white epoxy paint showed the major peaks found in both component parts A and B of the epoxy paint system.

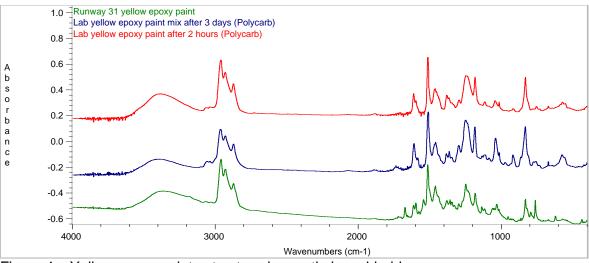
Figure 4 – Yellow epoxy paint extracts using methylenechloride

Both field and laboratory samples (reference materials) of the yellow epoxy paint showed the major peaks found in both component parts A and B of the epoxy paint system.
